HONOLULU AUTHORITY for RAPID TRANSPORTATION

PASSENGER VEHICLE FIRE RESISTIVITY TEST ISSUES

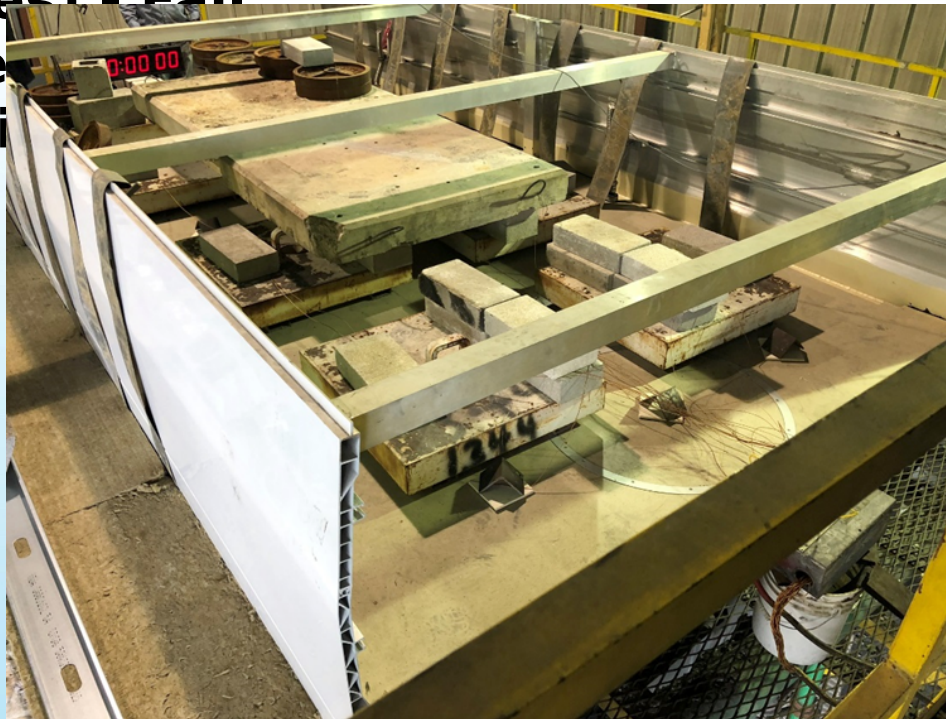
- **Floor**

- Passage of flames into the passenger compartment observed at 14:30 (less than 20 minutes) - Fail
- Loss of structural integrity at 19:38 (less than 20 minutes) - Fail
- Temperature and structural integrity

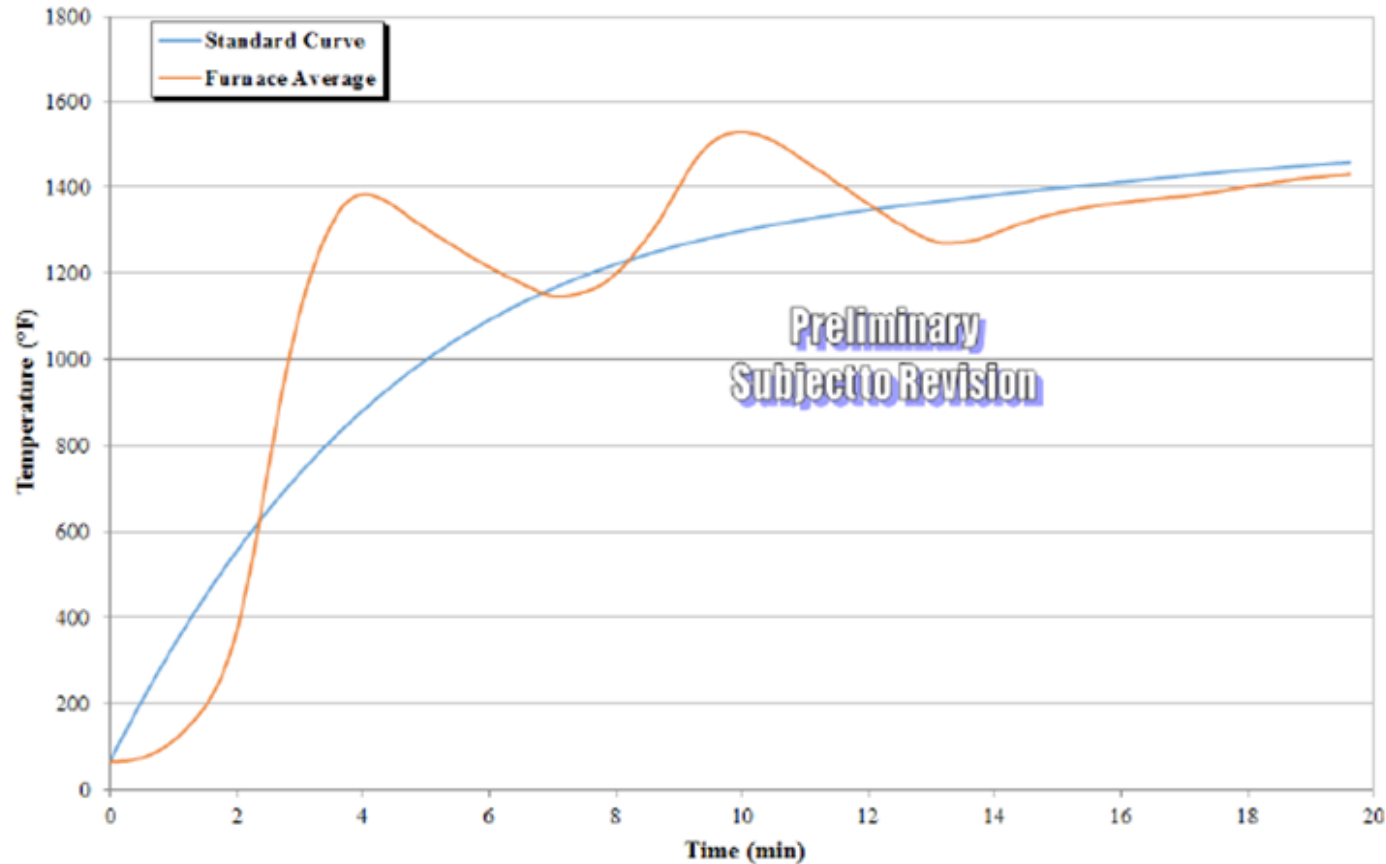
- **Floor Test-Furnace Temperature**

Test Date: February 25, 2019

Test ID: 19-056Hit603-1

- Test furnace reached 1,385°F after only 4 minutes during floor test (compared to specified ~850°F)
 - Test furnace reached 1,449°F after only 4 minutes during roof test (compared to specified ~850°F)

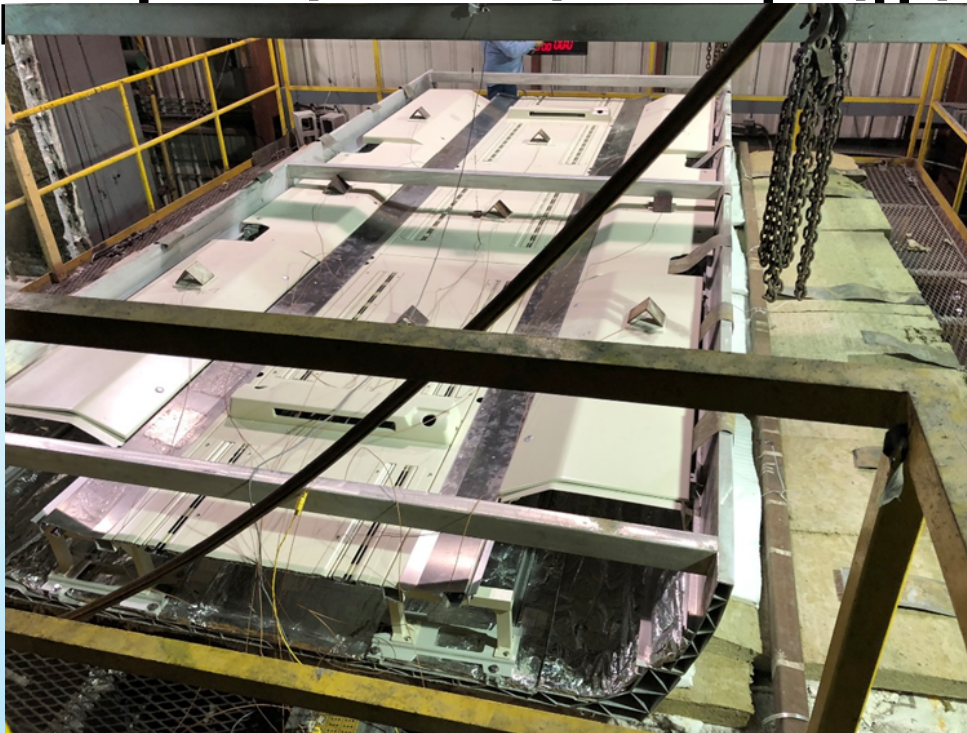
- **Roof**

- **Passage of flames into the passenger compartment observed at 16:30 (less than 20 minutes) - Fail**
- **No loss of structural integrity - Pass**
- **Temperature limits - Pass**

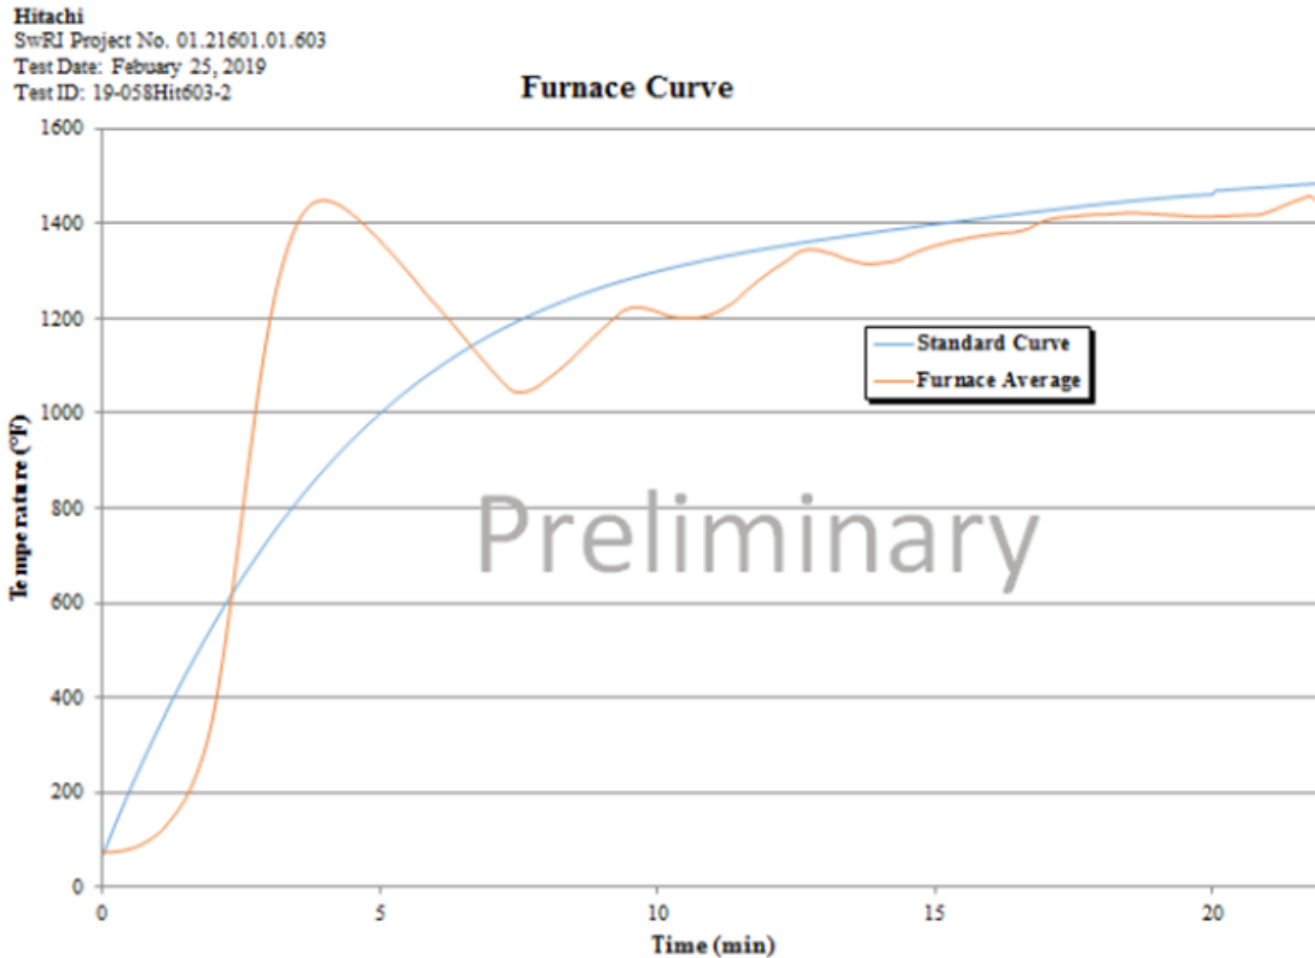
- **Roof Test - Furnace Temperature**
